# Manhole Inspection Summary

Manhole # S25G\_\_002MH

Insp Date: **8/31/07 10:38 AM**

**Location** Address: **105 CARROLLTON AVE**

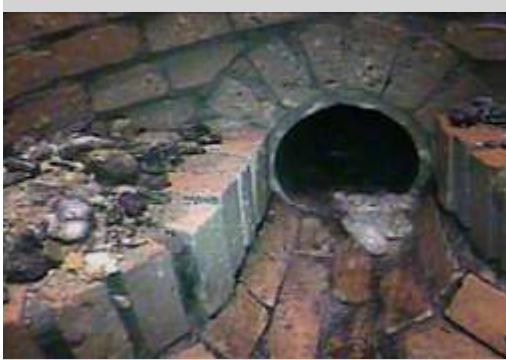
Defect 5

Condition: ☐ Sound ☐ Cracked ☐ Root Intrusion ☐ Deteriorated ☐ Leaks ☒ **Debris**

DEBRIS

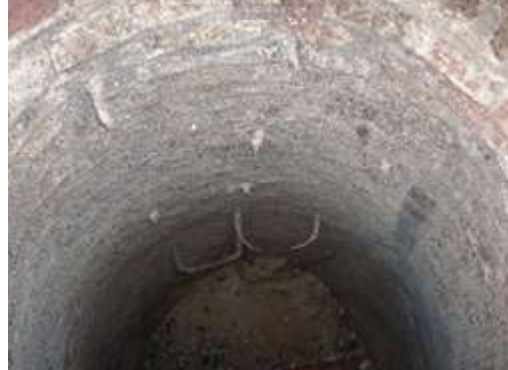
Defect 4

Count: **2** Missing: **4** ☒ **Corroded**

CORRODED AND MISSING STEPS

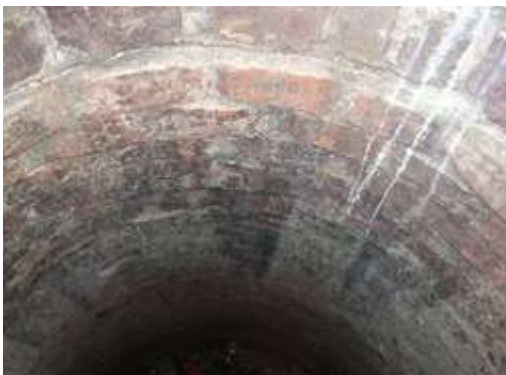
Defect 3

Infiltration: ☐ None ☐ Joint ☐ Cracks ☐ Mortar ☐ Roots ☒ **Wall**

INFILTRATION OF CORBEL WALL

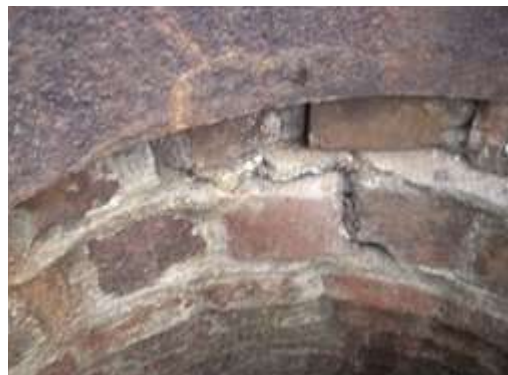
Defect 2

Condition: ☐ Sound ☐ Cracked ☐ Root Intrusion ☐ Loose Brick ☒ **Deteriorated**

DETERIORATED CHIMNEY

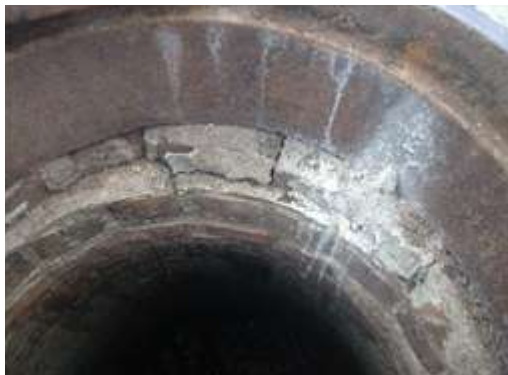
### Defect 1

Offset: **2** (in.)

Condition: ☐ Sound ☒ **Cracked** ☐ Leaks

FRAME OFFSET

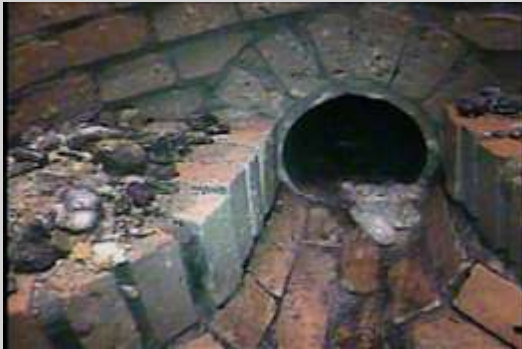
12 O'Clock Outflow

Pipe Height: **8.4** (in.) Rod and Bar (Angled)  
Pipe Material: **Clay** ☐ Pipe Lined  
Invert Depth: **10.59** (ft.) Flow Characteristics: **Slow**  
Deposits: ☐ None ☐ Mud ☐ Sludge ☒ **Debris** ☐ Grease  
Silt Depth: **1** (in.) Deposits Extent: **Light**  
Infiltration: **None** Pipe Seal Cond: **Sound**

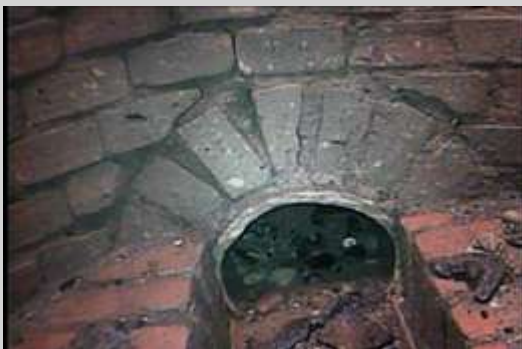
3 O'Clock Inflow

Pipe Height: **7.2** (in.) Rod and Bar (Angled)  
Pipe Material: **Clay** ☐ Pipe Lined  
Invert Depth: **9.83** (ft.) Flow Characteristics: **None**  
Deposits: ☐ None ☐ Mud ☐ Sludge ☒ **Debris** ☐ Grease  
Silt Depth: **2** (in.) Deposits Extent: **Light**  
Infiltration: **None** Pipe Seal Cond: **Sound**

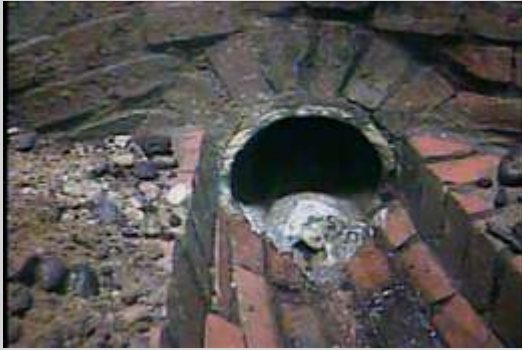
9 O'Clock Inflow

Deposits: ☐ None ☐ Mud ☐ Sludge ☒ **Debris** ☐ Grease

Infiltration: **None** Pipe Seal Cond: **Broken**
